TREATING A BROKEN WRIST

By Philip Tom

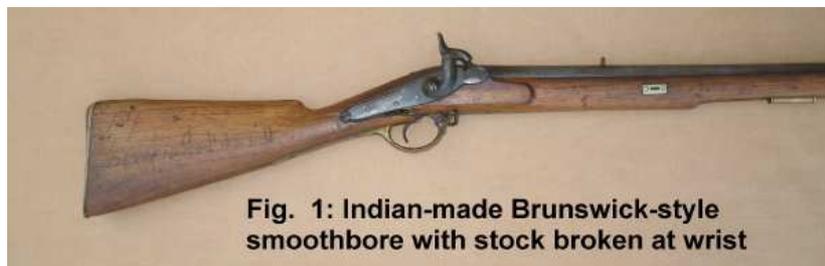
Fig. 1: Indian-made Brunswick-style smoothbore with stock broken at wrist

This is a "broke in shipment" case: a partial break (I suppose the medical profession would call this a greenstick fracture) between the lockplate and trigger guard of an Indian or Nepali knockoff of a Brunswick percussion rifle. The wood resembles walnut but is rather soft and weak to begin with, and the entire gun is a smoothbore, fixed-sight down-market version of what should otherwise be a well-designed and crafted British service rifle. Despite its relative lack of good workmanship, it's a historically interesting piece with loads of Nepali markings and an undoubtable association with the Gurkhas.

Figs. 1-3 show the piece from both sides, as received. Not only was the wood damaged, but the relatively flimsy brass trigger guard tangs had bent as well. Repair was made somewhat easier by the fact that the break occurred recently and the fractured surfaces were still clean -- no oil or gunk had gotten inside. An exception was a small crack under the lockplate which looked old because the wood inside was darkened. For good measure, the area was cleaned from the inside with dental picks and acetone swabs, being

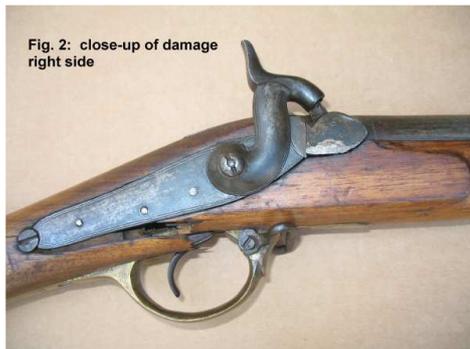
Fig. 2: close-up of damage right side

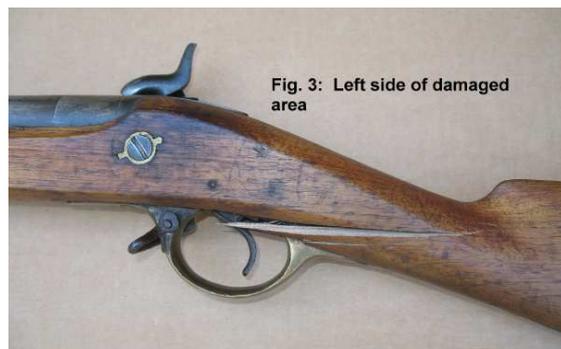
Fig. 3: Left side of damaged area
