TREATING A BROKEN WRIST

By Philip Tom

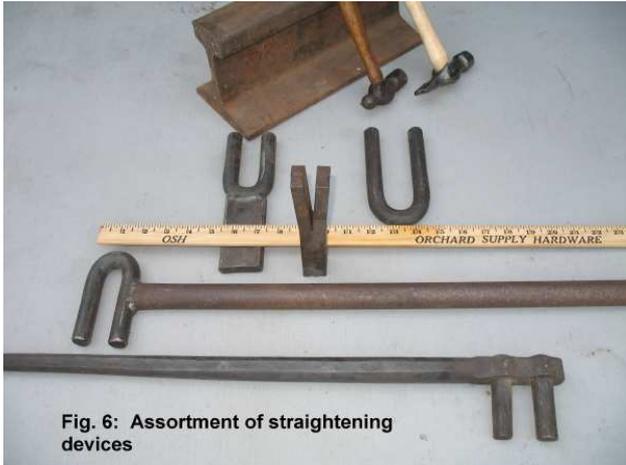
Fig. 6: Assortment of straightening devices

Fig. 6 shows an assortment of tools used for straightening bent metal parts. Don’t expect to find these at Home Depot or your neighborhood Ace Hardware, they all need to be custom-made. In principle, they are pretty simple things, and the yardstick gives an idea of their size. A competent blacksmith or welder should be able to fabricate these easily; mine were made by colleagues who are sword smiths. At the back of the picture is an anvil made from a section of rail, plus a couple of hammers.
